**Draft Closeout Report  
for IHSS Group 000-5  
(Present Landfill [IHSS 114])**

**June 22, 2005**

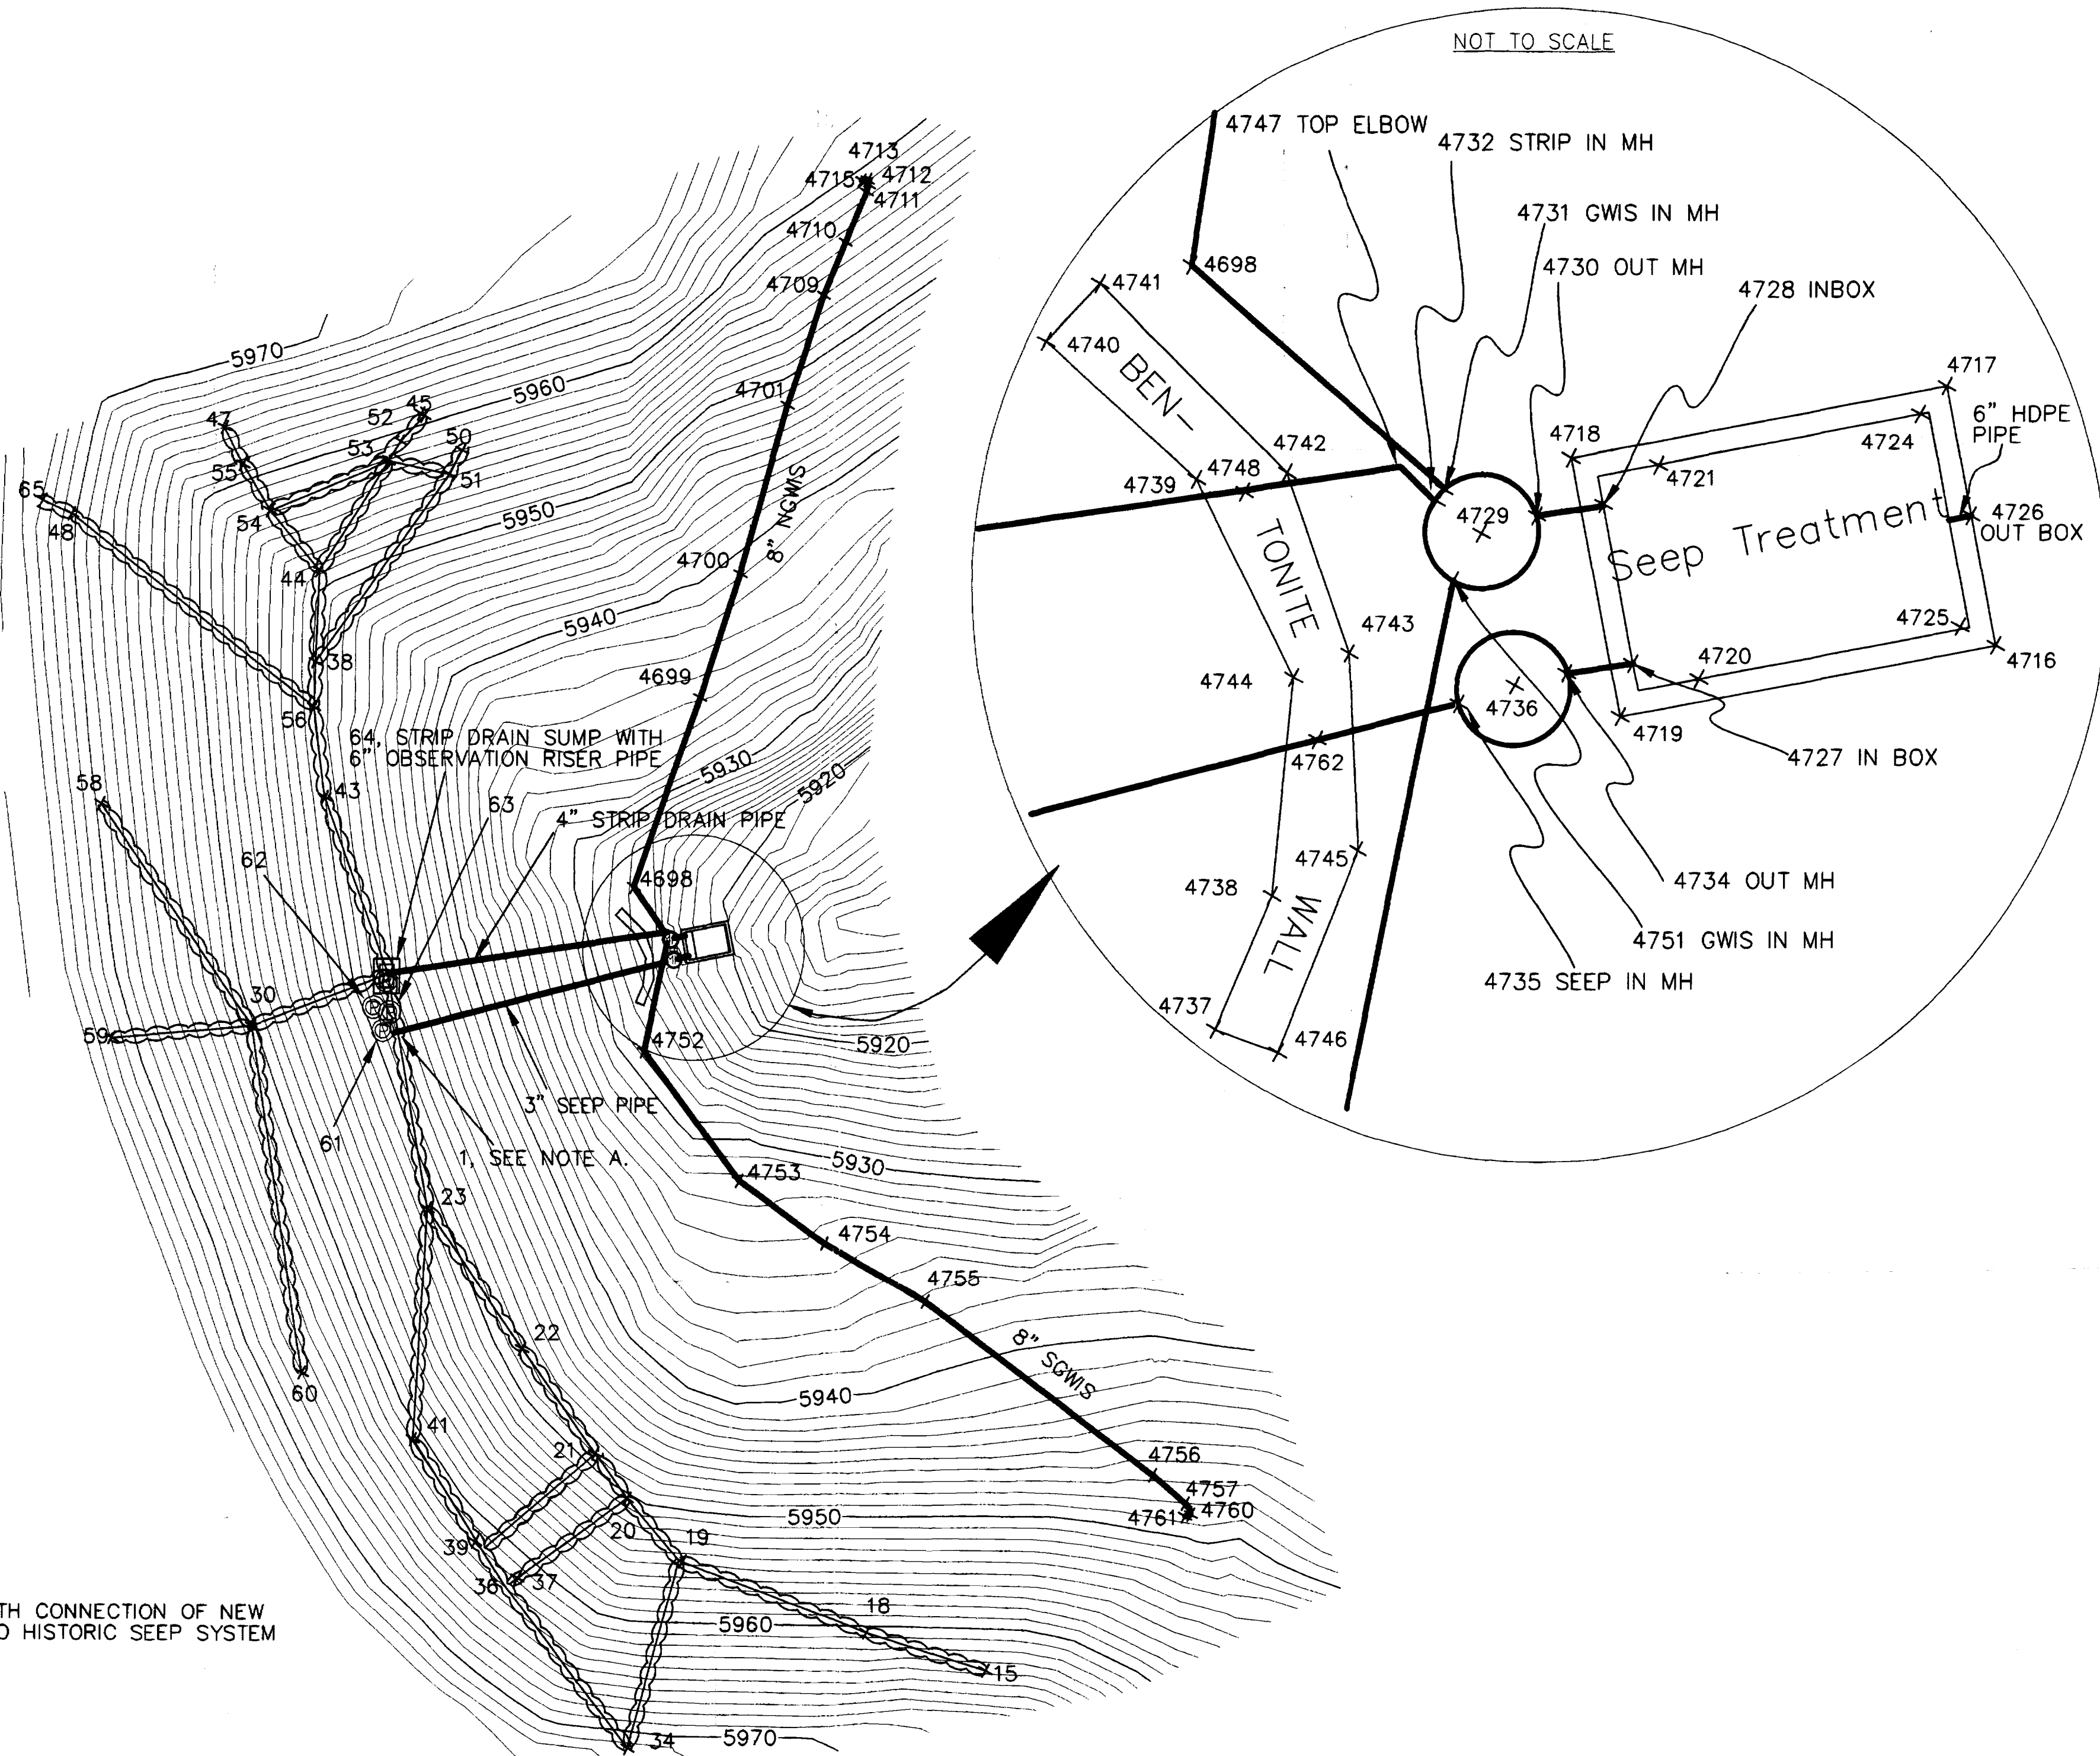
SHEET 3 OF 3---ASBUILT OF NEW SEEP TREATMENT SYSTEM

NOTES:  
A. 1. FEB 19TH CONNECTION OF NEW  
SYSTEM TO HISTORIC SEEP SYSTEM

POINT	NORTHING	EASTING	ELEVATION	
1	39865.00	20861.31	5922.85	CP1BD-CONNECT EXIST SEEP
15	39864.21	21070.61	5960.31	STRIP DRAIN
18	39655.56	21028.44	5954.79	STRIP DRAIN
19	39680.90	20962.42	5946.98	STRIP DRAIN
20	39702.75	20944.02	5943.28	STRIP DRAIN
21	39718.67	20932.87	5941.84	STRIP DRAIN
22	39755.40	20906.84	5939.63	STRIP DRAIN
23	39803.92	20873.26	5936.16	STRIP DRAIN
30	39867.26	20810.83	5946.52	STRIP DRAIN
34	39614.74	20944.32	5965.06	STRIP DRAIN
36	39672.28	20900.74	5957.19	STRIP DRAIN
37	39674.72	20905.39	5955.60	STRIP DRAIN
38	39994.11	20832.98	5942.40	STRIP DRAIN
39	39695.08	20905.47	5950.52	STRIP DRAIN
41	39723.69	20868.35	5954.86	STRIP DRAIN
43	39946.39	20836.31	5939.16	STRIP DRAIN
44	40026.16	20834.29	5944.95	STRIP DRAIN
45	40080.41	20871.33	5947.77	STRIP DRAIN
47	40076.28	20800.73	5952.89	STRIP DRAIN
48	40045.65	20746.72	5963.49	STRIP DRAIN
50	40068.18	20884.69	5947.62	STRIP DRAIN
51	40059.97	20880.11	5946.73	STRIP DRAIN

POINT	NORTHING	EASTING	ELEVATION	
4736	39890.55	20959.62	5919.04	MANHOLE FLOOR, SOUTH
4737	39875.78	20946.55	5926.8	TOP CLAY WALL , 19.0 BOTTOM
4738	39881.55	20949.05	5925.9	TOP CLAY WALL , 19.0 BOTTOM
4739	39899.79	20945.67	5925.7	TOP CLAY WALL , 19.0 BOTTOM
4740	39905.79	20939.03	5925.4	TOP CLAY WALL , 19.0 BOTTOM
4741	39908.30	20941.41	5925.3	TOP CLAY WALL , 19.0 BOTTOM
4742	39900.08	20949.66	5925.9	TOP CLAY WALL , 19.0 BOTTOM
4743	39892.19	20952.48	5925.9	TOP CLAY WALL , 19.0 BOTTOM
4744	39891.10	20949.97	5925.9	TOP CLAY WALL , 19.0 BOTTOM
4745	39883.52	20952.86	5926.0	TOP CLAY WALL , 19.0 BOTTOM
4746	39874.75	20949.32	5926.8	TOP CLAY WALL , 19.0 BOTTOM
4747	39899.41	20955.58	5924.32	TOP 6\"/>
4748	39898.21	20948.27	5924.59	TOP 8\"/>
4751	39896.18	20957.35	5924.50	TOP 8\"/>
4752	39858.67	20949.38	5926.64	TOP 8\"/>
4753	39813.67	20983.18	5927.99	TOP 8\"/>
4754	39792.12	21013.16	5930.16	TOP 8\"/>
4755	39772.27	21048.94	5934.17	TOP 8\"/>
